الحماية الكاثودية للهياكل الخرسانية المسلحة المتآكلة

**CATHODIC PROTECTION OF CORRODED REINFORCED
CONCRETE STRUCTURE**

Dept. of Civil Engineering, Palestine Polytechnic University, Hebron,
Palestine

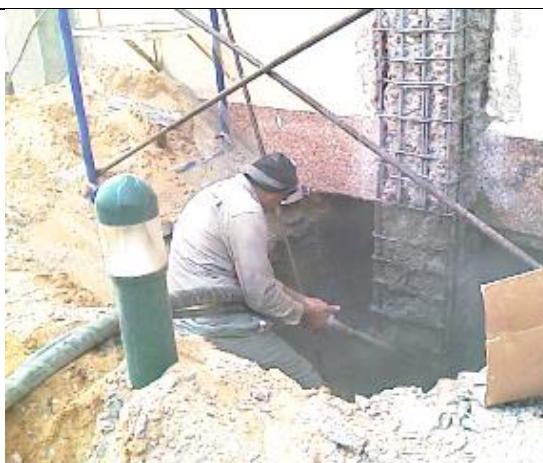
Fig. 4 Grout Spraying using Shotcrete

By opting for sprayed concrete instead of the form-and-pour repair technique, the need for extensive formwork was reduced, resulting in quicker repair times. The dry spray technique, with water added at the nozzle, was employed for the application of the sprayed concrete overlay.

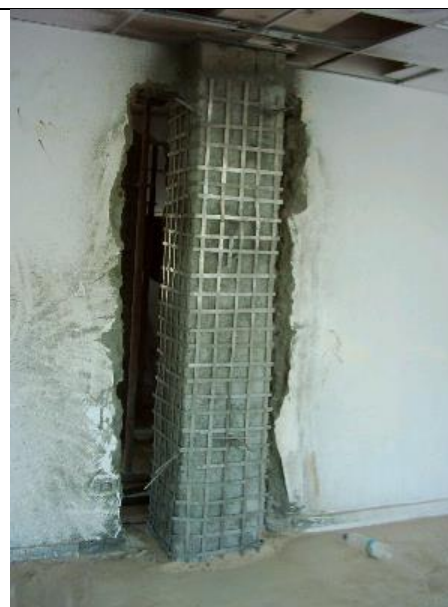
During the second stage, a zinc mesh was installed on the surface of the columns, as depicted in Figures 3, 4, and 5. A strip was bent to extend outside the column. Over the zinc mesh, a 15 mm thick plaster layer was applied. An impressed current was then introduced, with the zinc leg connected to the positive pole and the stirrup leg connected to the negative pole of a DC power supply. Throughout the 7-day duration of current application, the column surfaces were kept moist. The potential difference of the current flow was monitored using a half-cell, as shown in Figure 6c.

Fig. 5 Grouting and zinc mesh installation

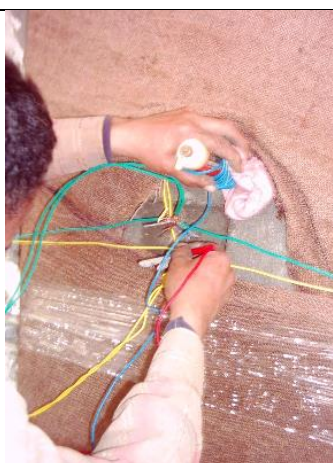
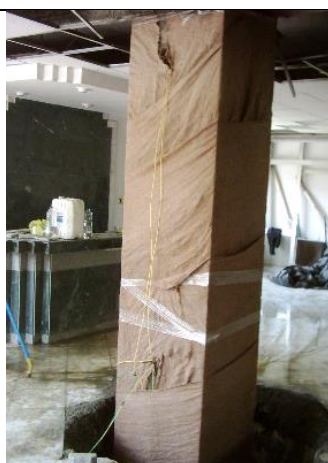
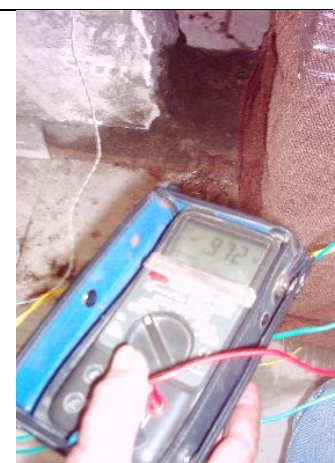
(a)	(b)	(c)
-----	-----	-----

Following the period of impressed current flow, the steel leg was connected to the zinc strip leg within a junction box. The flow of current from zinc to the steel cage was examined under wet conditions, as illustrated in Figure 6.

Fig. 6 Electric current (a) current connection, (b) treated Column, (c) voltmeter readings
